Case 324 : Narrative

Case Vehicle (A): 2000 Dodge
Type: Stratus SE, 4-door sedan
Driver: 20-year-old female
CDC: 12-FDEW-5

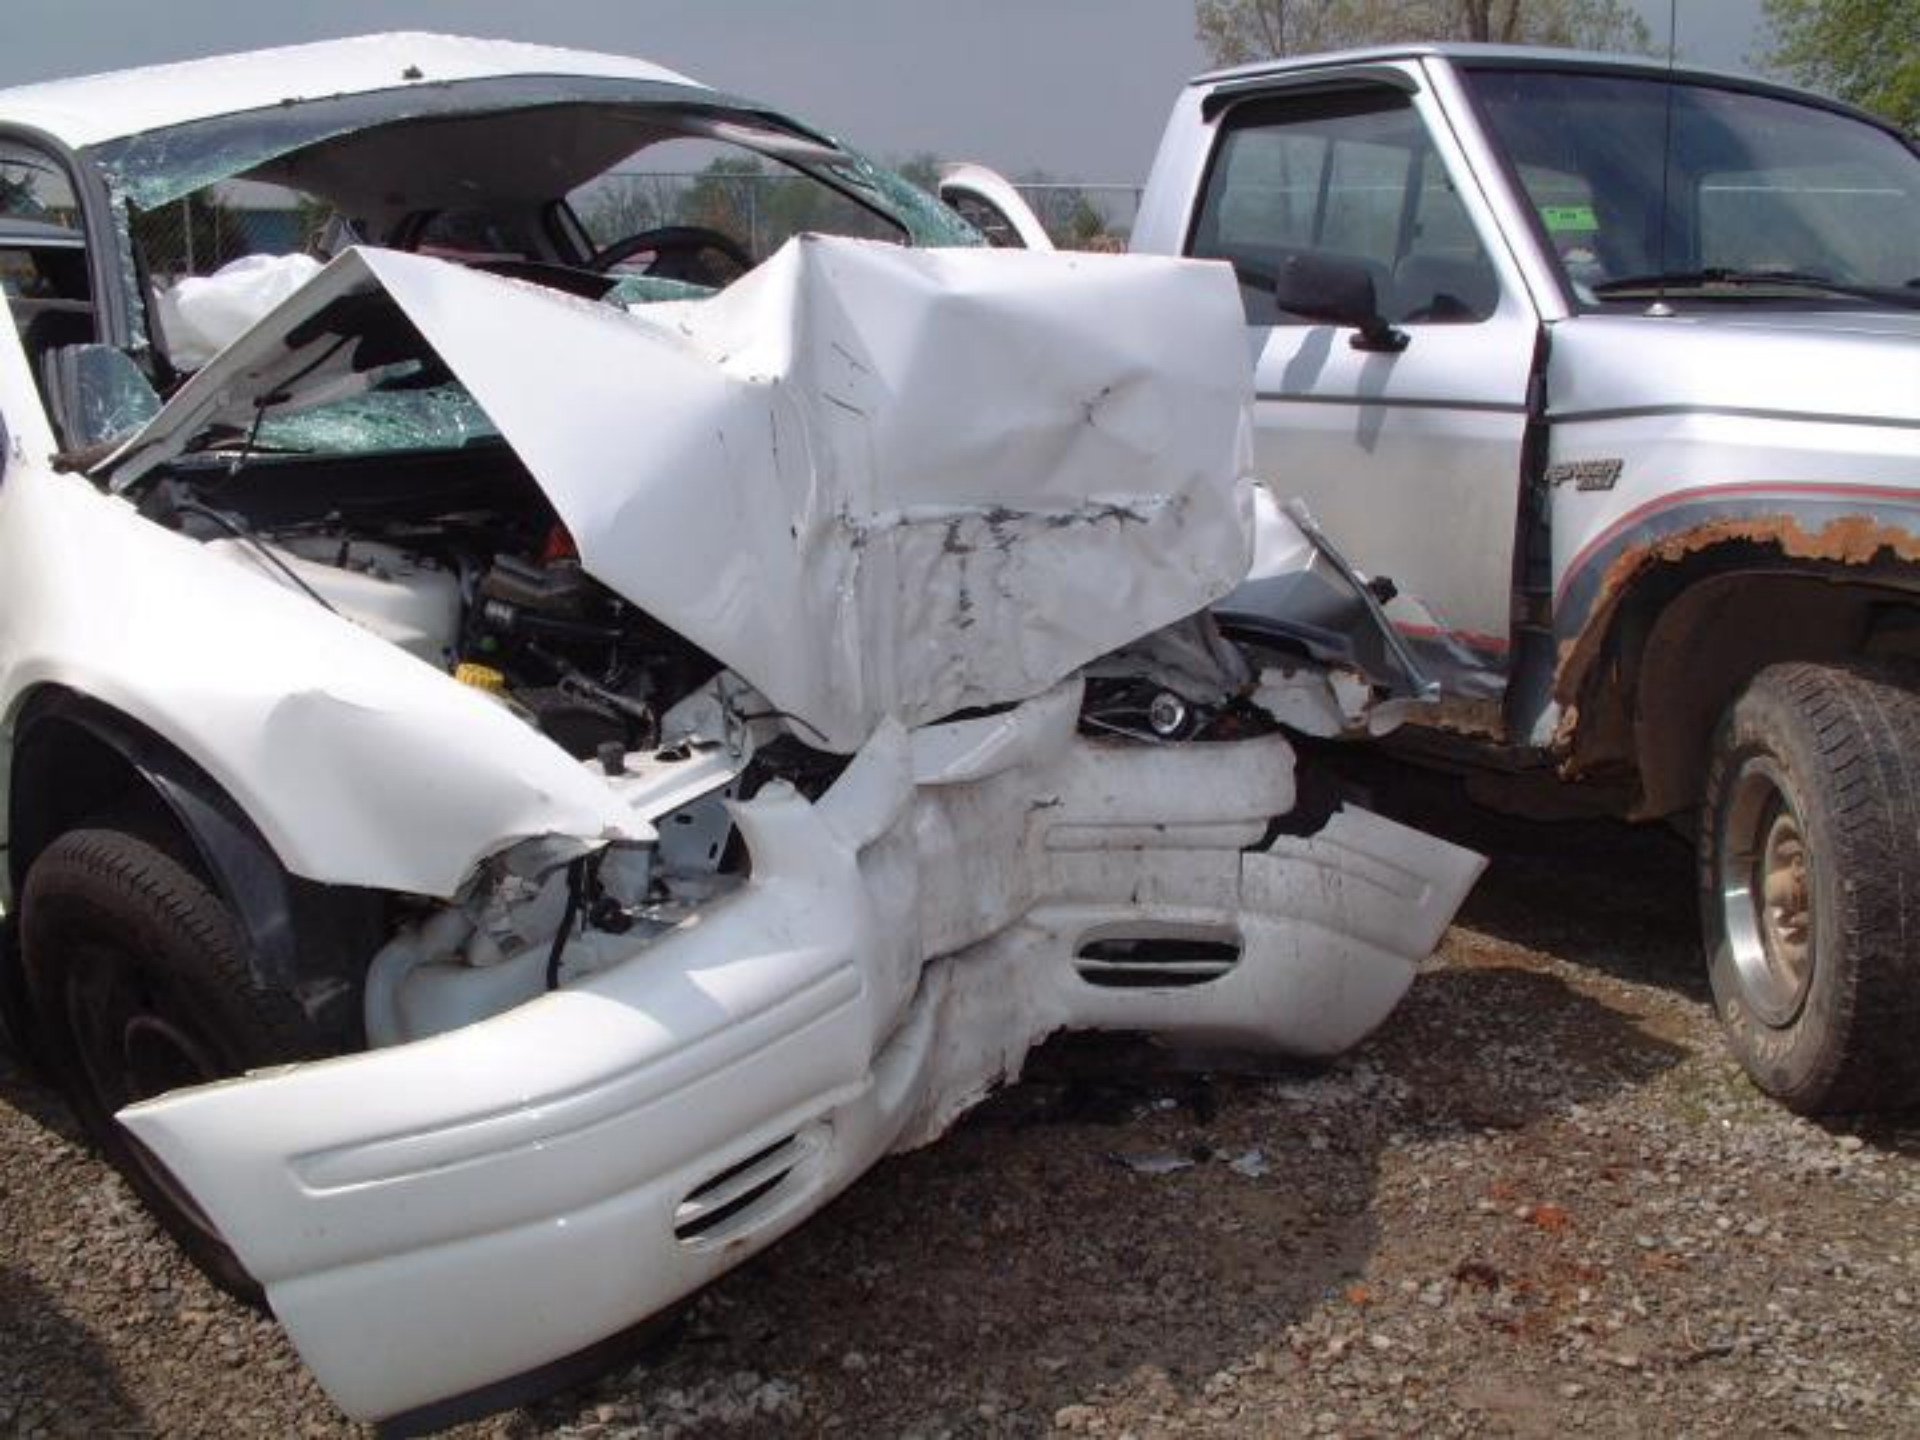
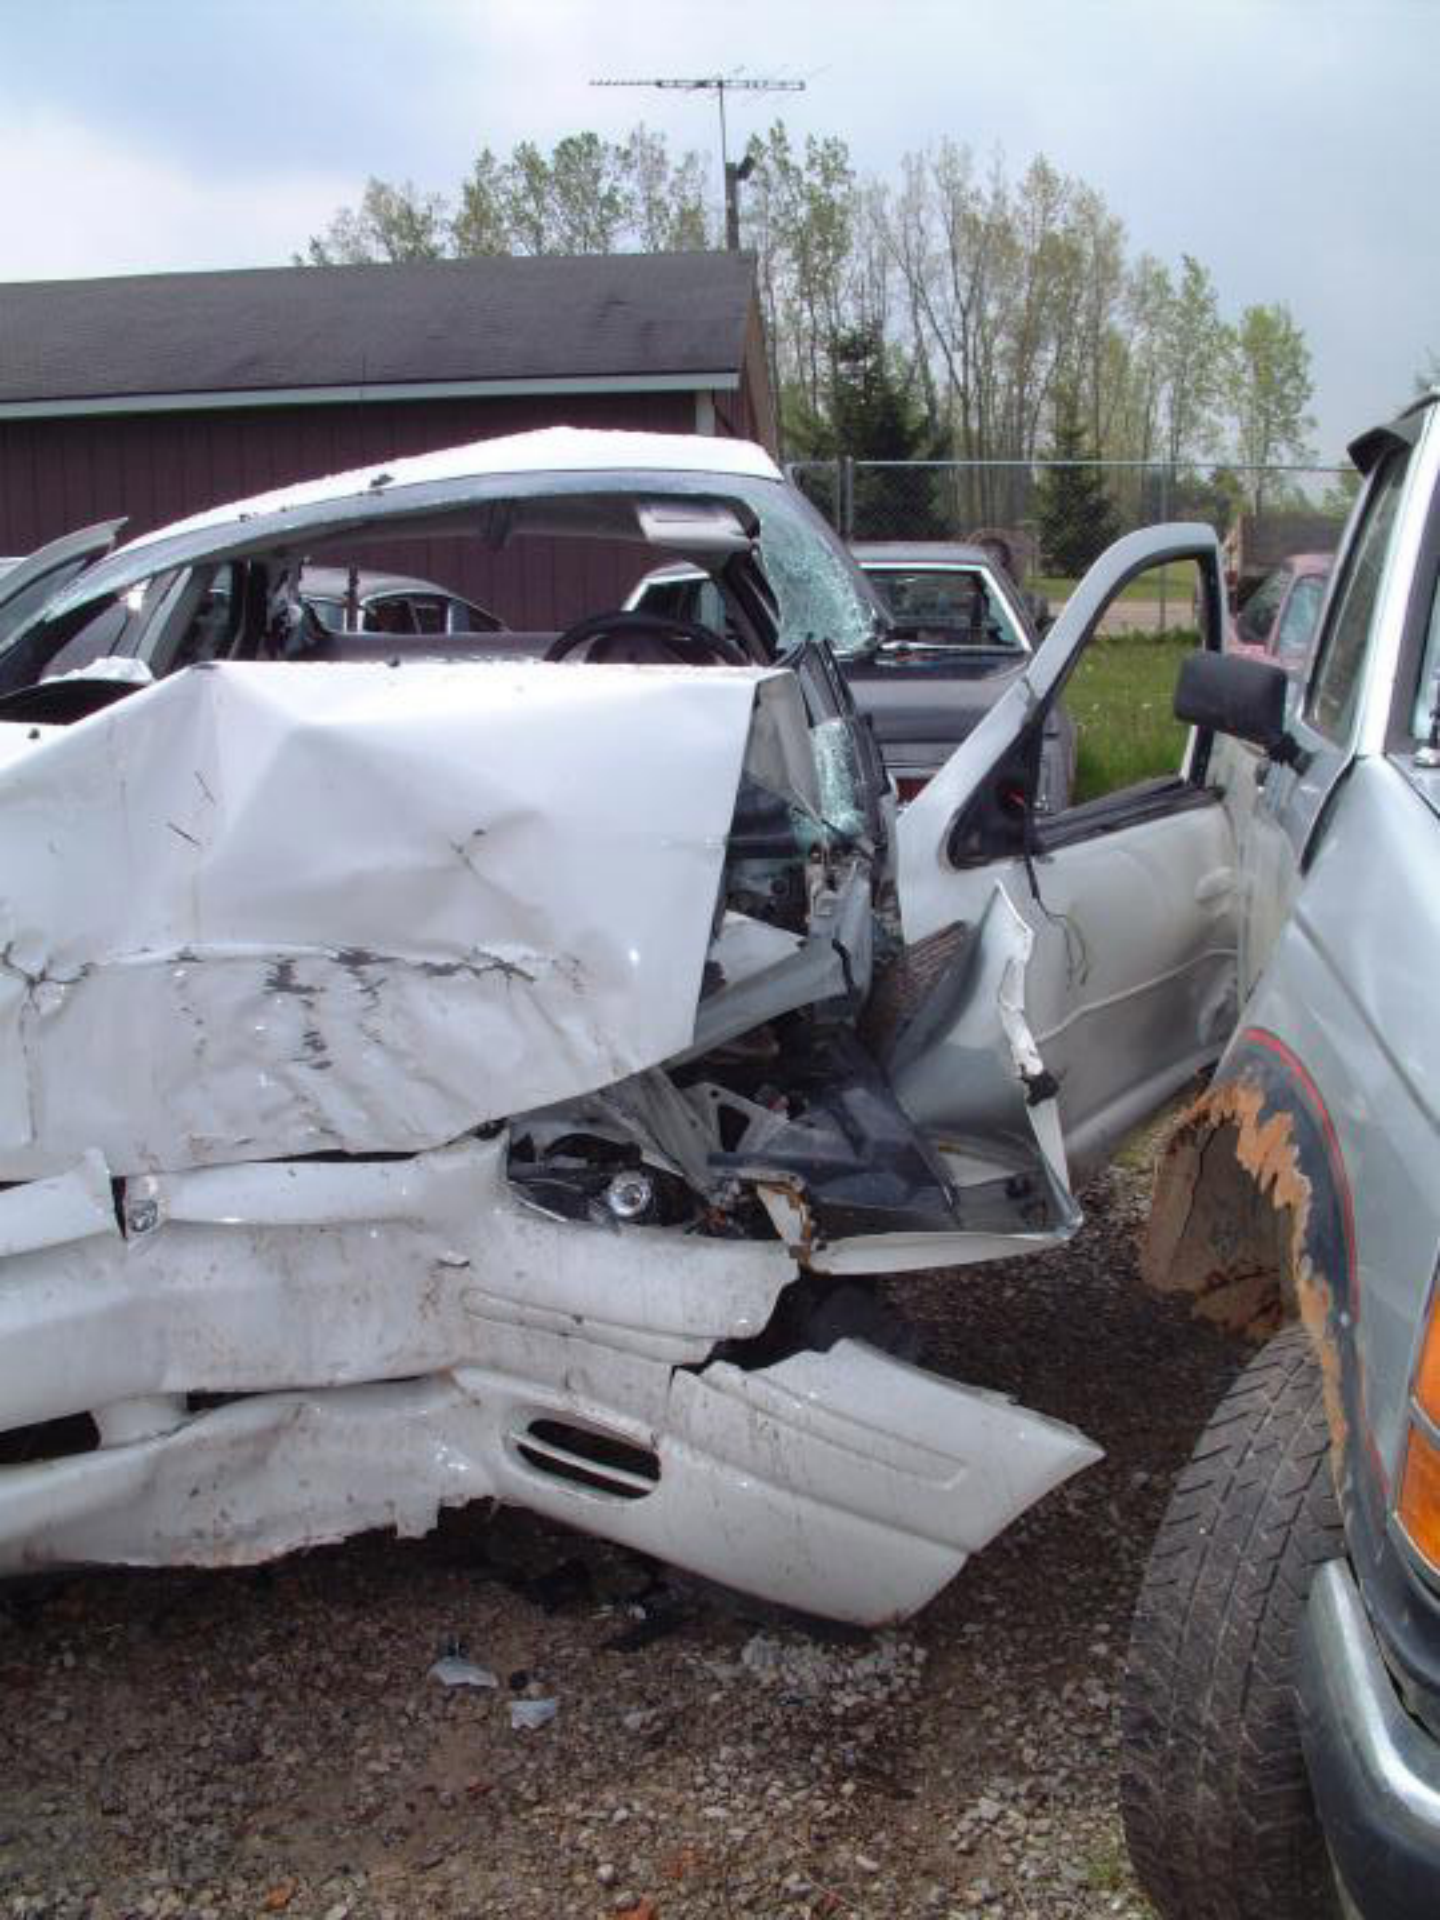
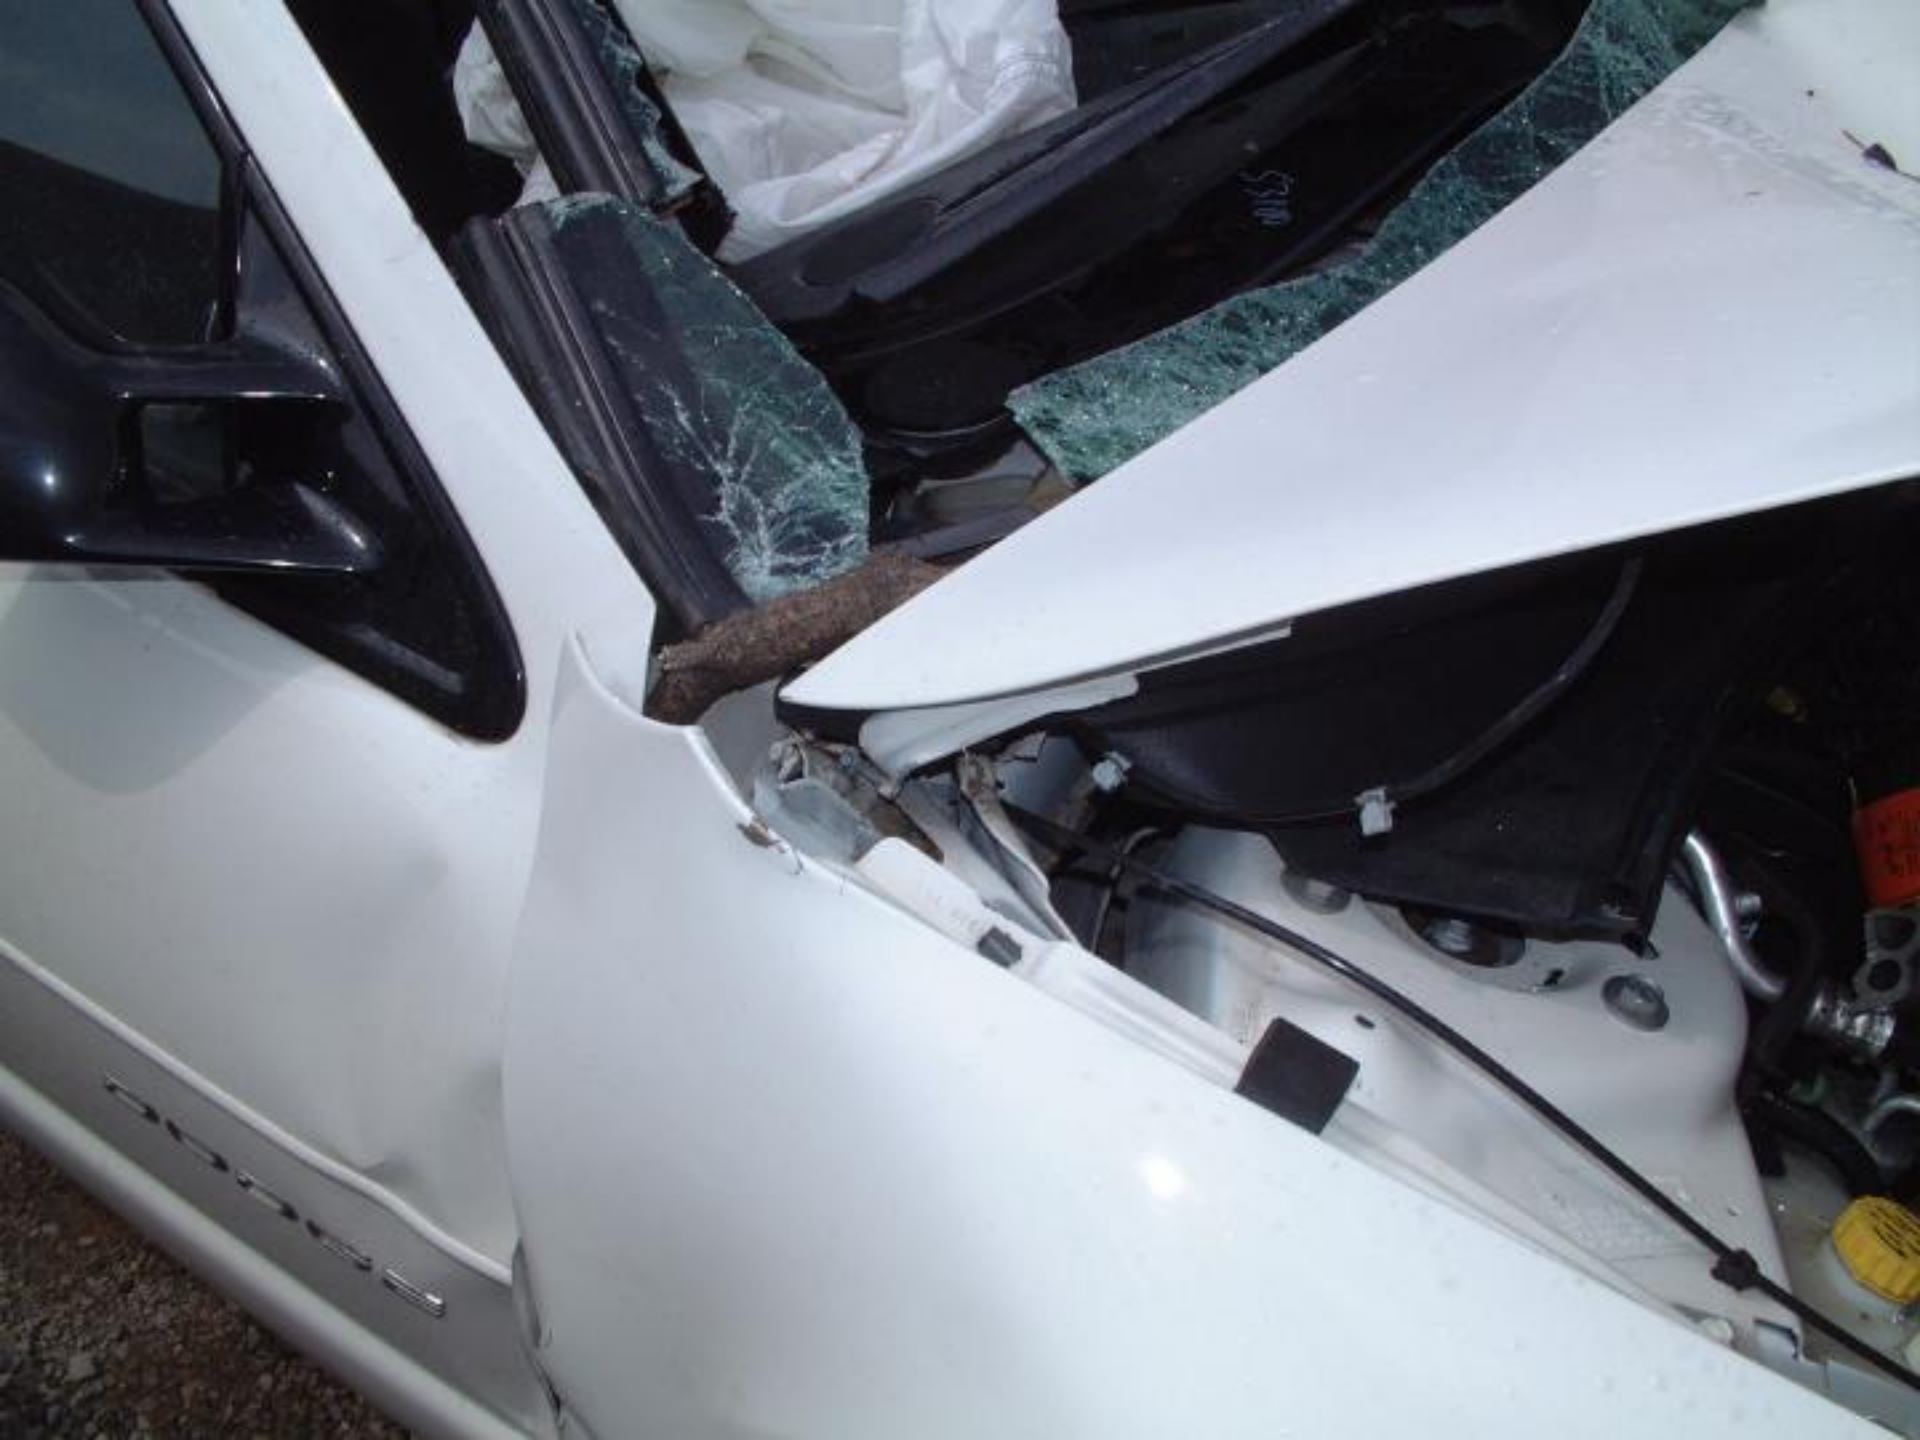
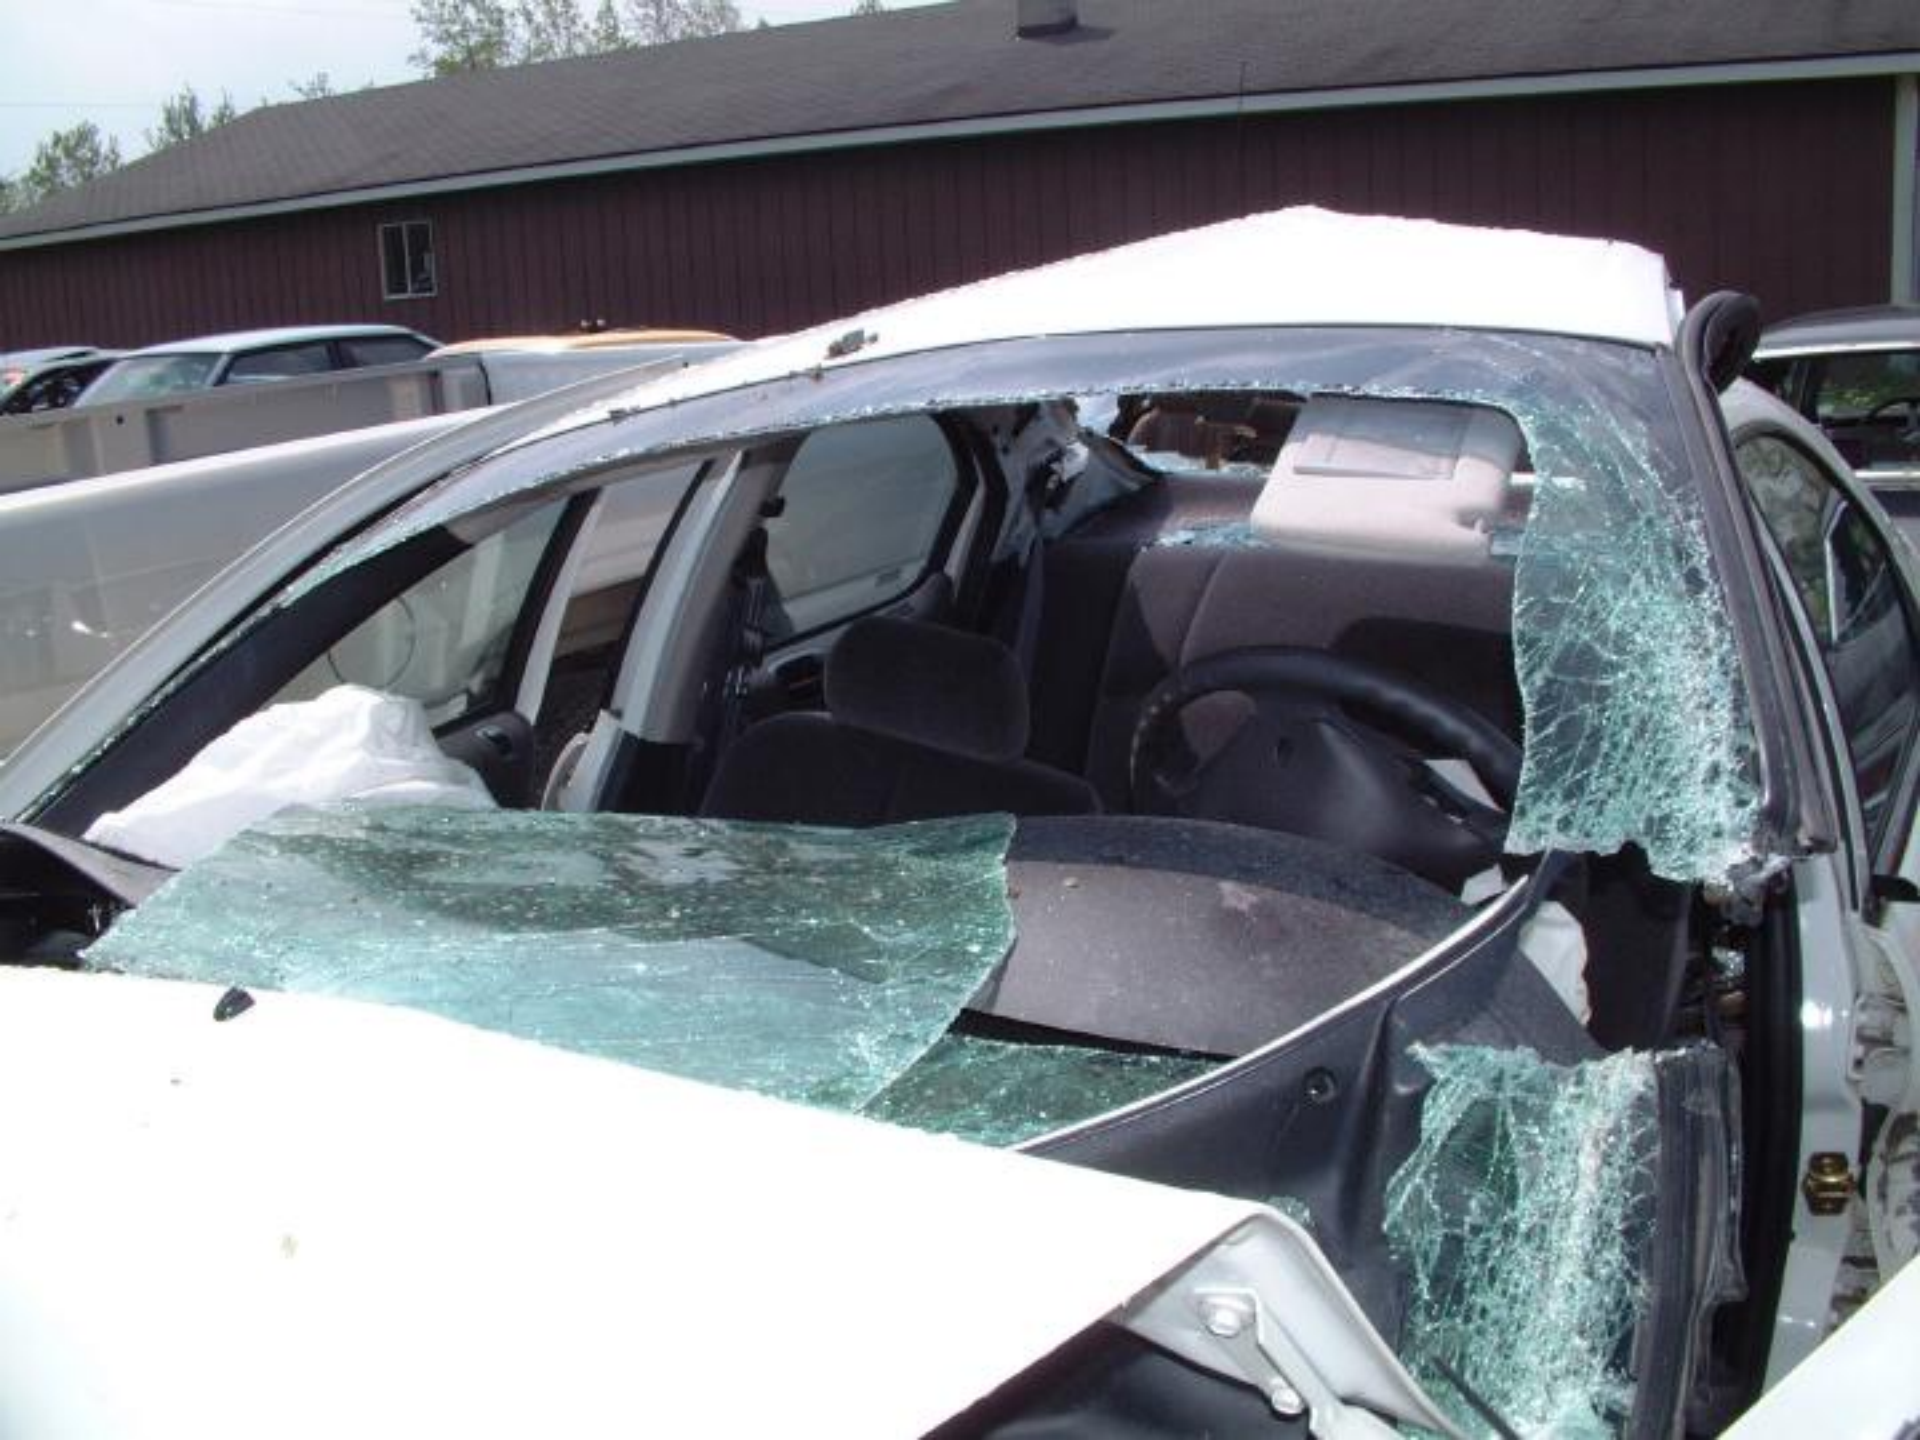
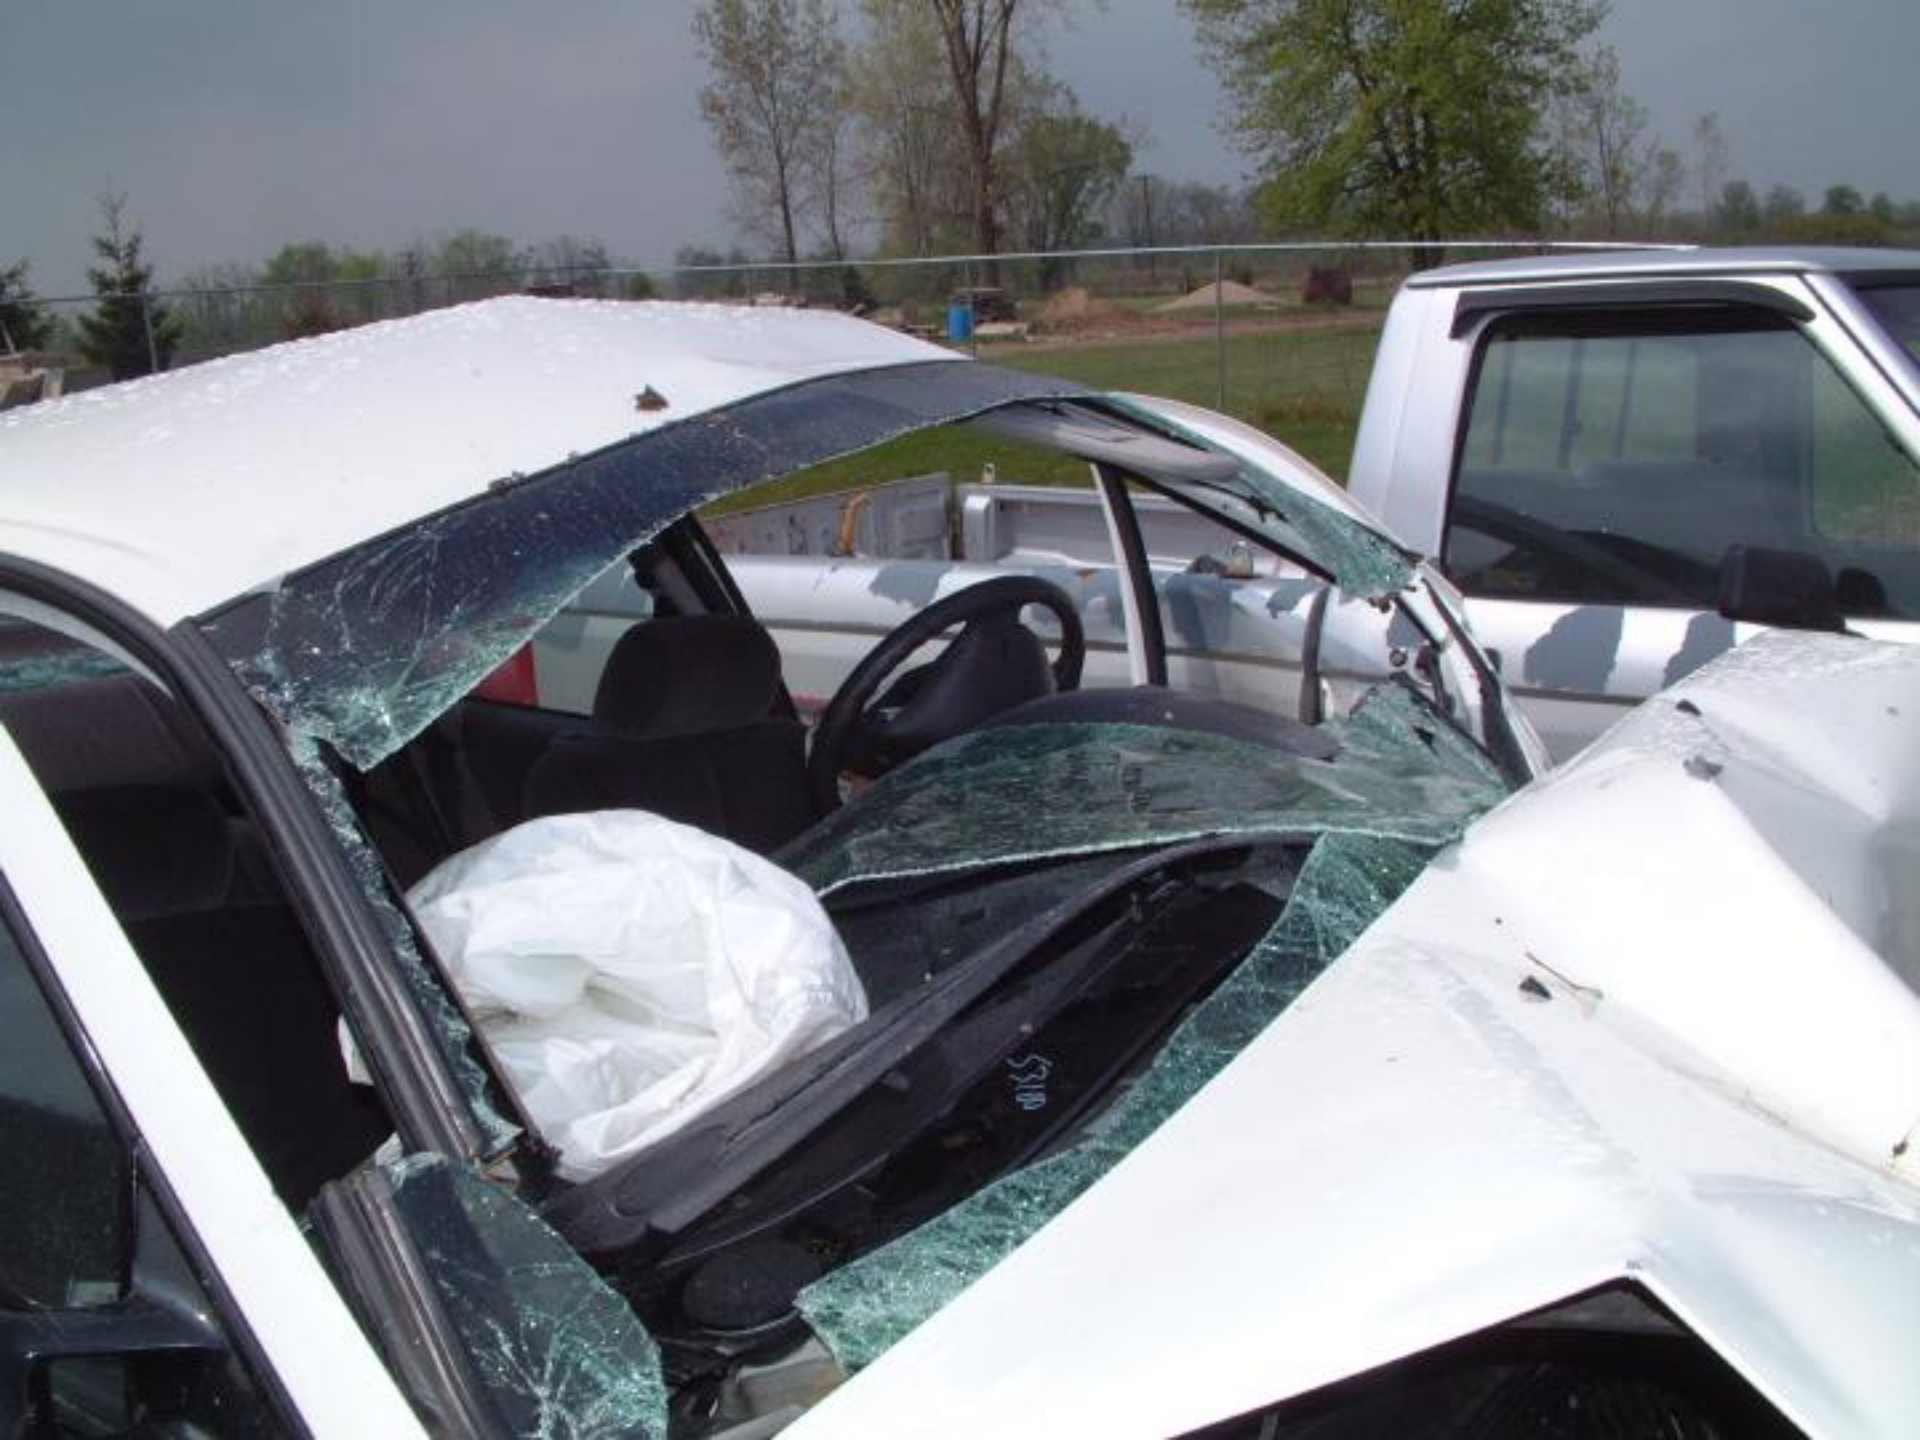
[33](#) [34](#) On the right side, the front fender was deformed and moved to the left. [35](#) The right-front wheel was slightly damaged and the right wheelbase was reduced 15 cm. [36](#) [37](#) The right-front door was deformed and jammed closed, and the lower portion of the A-pillar was deformed. There was no damage to the upper or lower portions of the right B- or C-pillars.
